CFD Application to Eliminate Delamination Defects in Flange Products

Aep Supriatna

Institut Sains dan Teknologi Nasional (ISTN), Indonesia

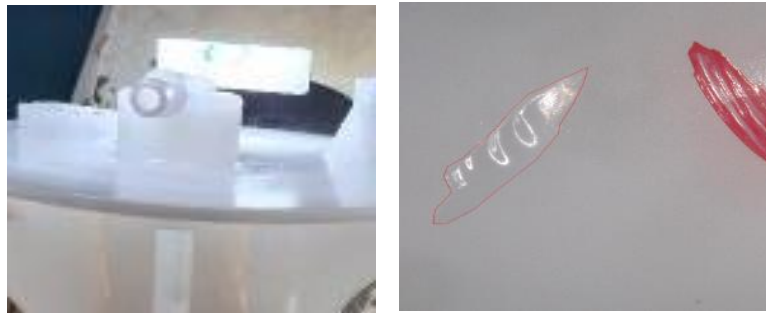
Figure 1
Delamination defects in breather pipe flange products

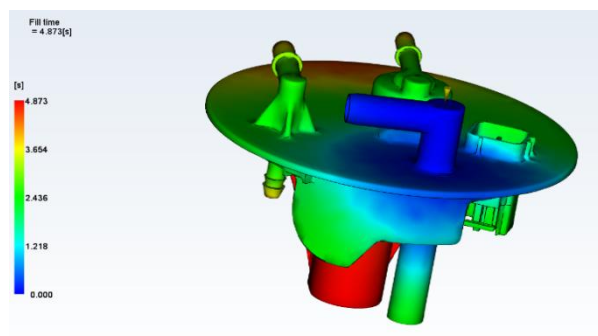
Figure 2
Fill time analysis

Filling the plastic resin into the mold, takes 4.87 seconds.

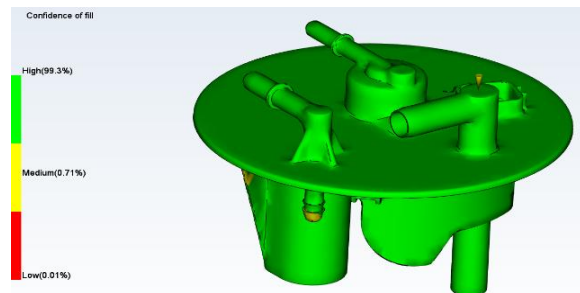
Gambar 3
Analysis Confident of fill

Based on the setting parameters used, the confidence of filling is 99.3%.

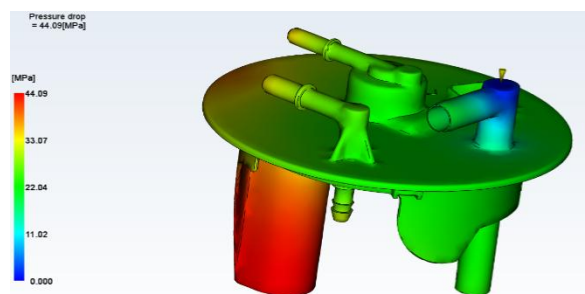
Figure 4
Pressure drop analysis

The pressure drop that occurred was 44.09 Mpa.

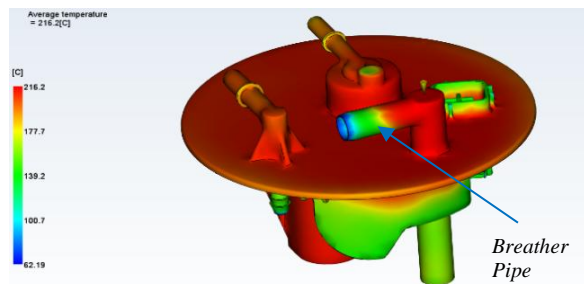
Figure 5
Temperature uniformity analysis

The average temperature is 216.2°C, but in the *breather pipe area*, there is a large enough temperature difference so there is the potential for delamination due to the lack of integrity between layers.

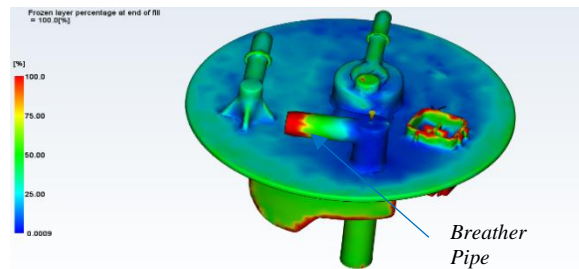
Figure 6
Frozen Layer Analysis

In the *breather pipe area*, there is a difference in the frozen layer on 1 surface.

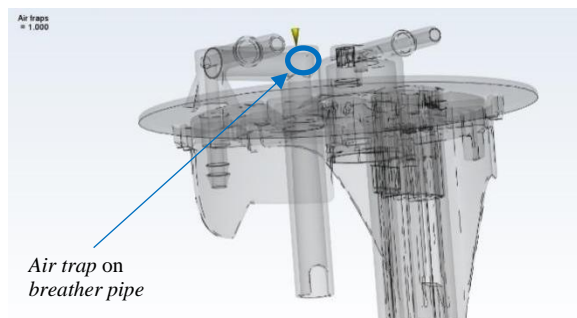
Figure 7
Analysis of Water Traps / trapped air

Air traps occur in the breather pipe area, this has the potential to cause voids due to gases that cannot get out of the mold.

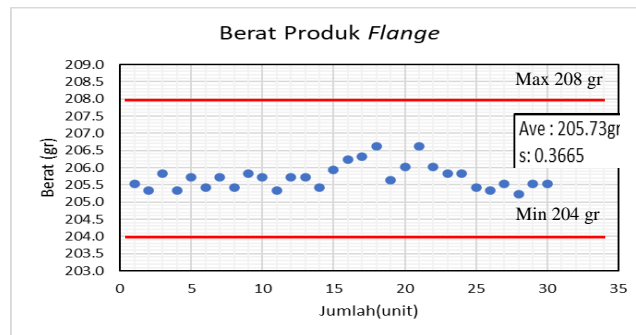
From the results of the CFD analysis, it can be seen that although the confidence of fill is very good (99.3%), in the breather pipe area there are potential problems due to the occurrence of temperature inhomogeneity, frozen layer, and the presence of air traps. The pressure drop value that occurs (44.09 Mpa) and the filling time required (4.87 seconds) are still below the actual value of the setting parameters on the injection machine so it is still considered safe and proven by the weight stability of the product.

Figure 9 Weight Stability of Flange Products

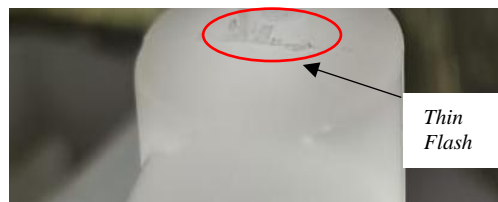
Plastic debris appear due to a thin *flash* in the parting line area near the *gate* that is easy to come off. The plastic debris that are sticky are also affected by the new resin material.

Figure 10
Thin Flash occurs on the parting line due to the failure of the slider core part

1. Eliminates thin flashes that easily fall off with the repair of the slider core to normal conditions.
2. Modification of cylinder rod to provide clearance of 0.5 mm.
3. The addition of gas vents in the slider area with a vacuum system to eliminate air traps as the cause of gas burn.

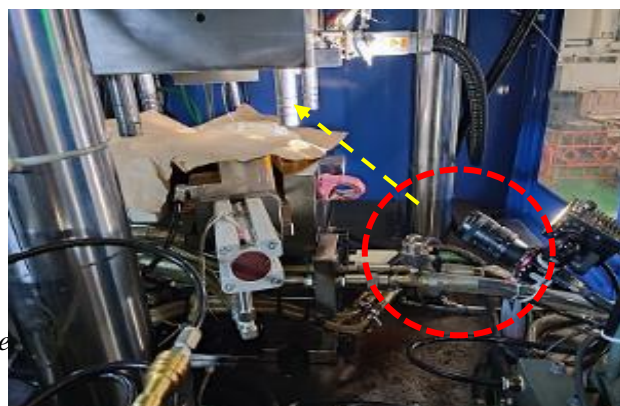
Ensuring the source of plastic debris from the cylinder injection process and hot runner is carried out by checking the high speed camera through the mold purging method.

Figure 11
Checking foreign materials with a high speed camera

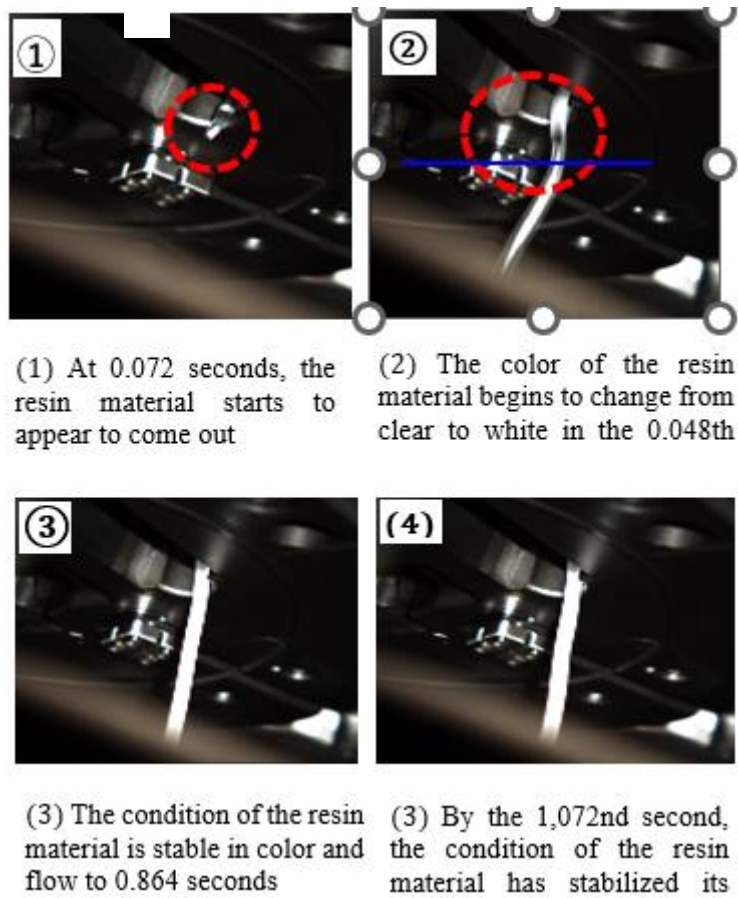
Figure 12
Results of checking foreign materials with high speed camera

From the results of checking the high camera, there was no foreign *material* , *bubbles* or delamination. Failure mechanism on *core scratch slider* and *gas burn problem*:

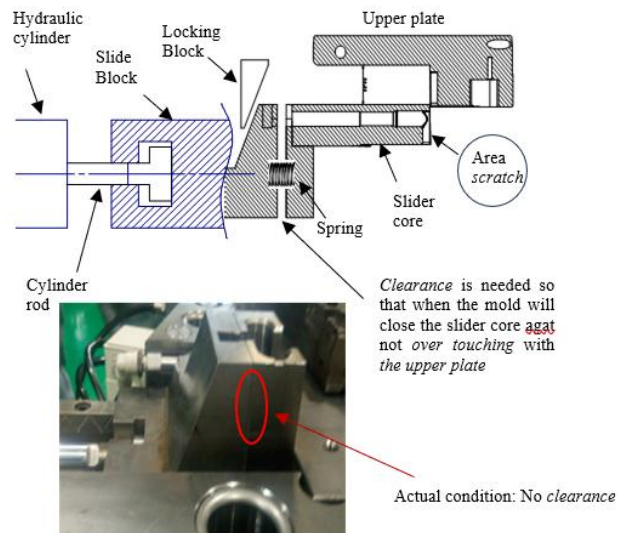
Figure 12 Mold Mechanism when closing

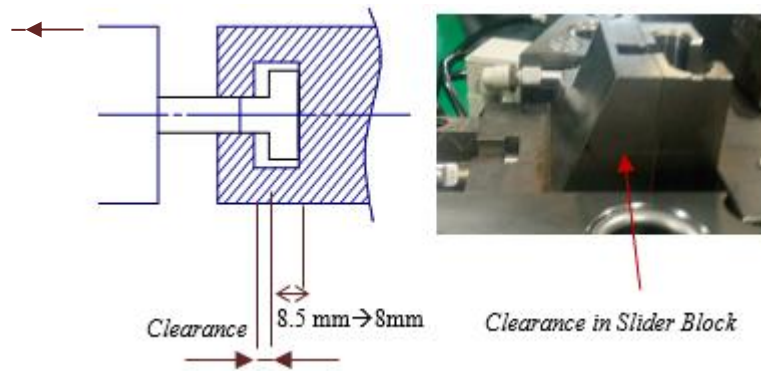
Figure 14
Cylinder Rod Modification

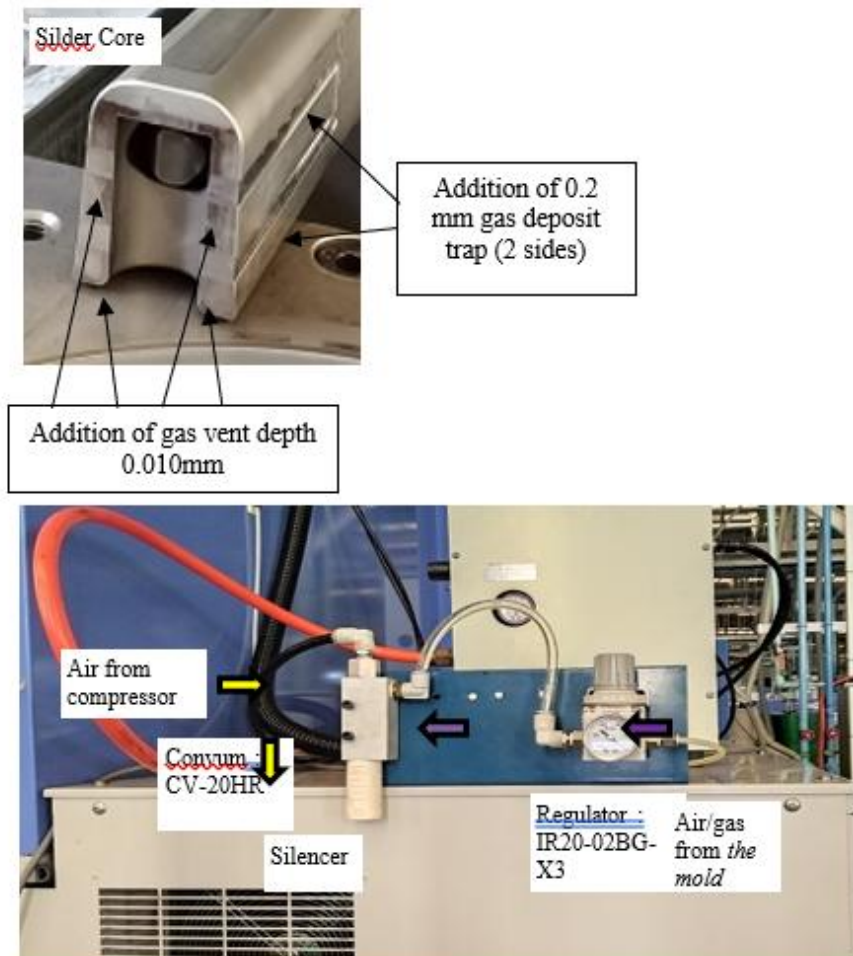
Figure 15
Addition of a gas vent to the slider core with a vacuum system

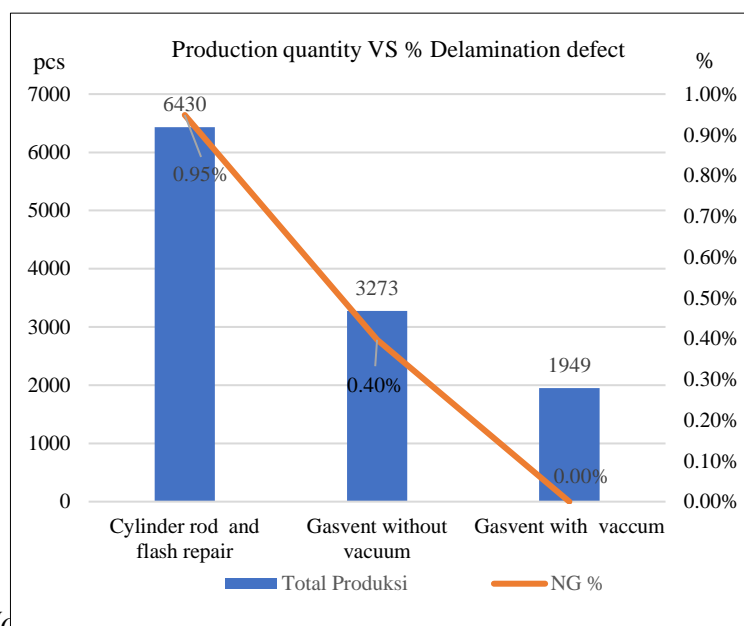
Figure 16
Graph 2 Production Data after 3 stages of improvement

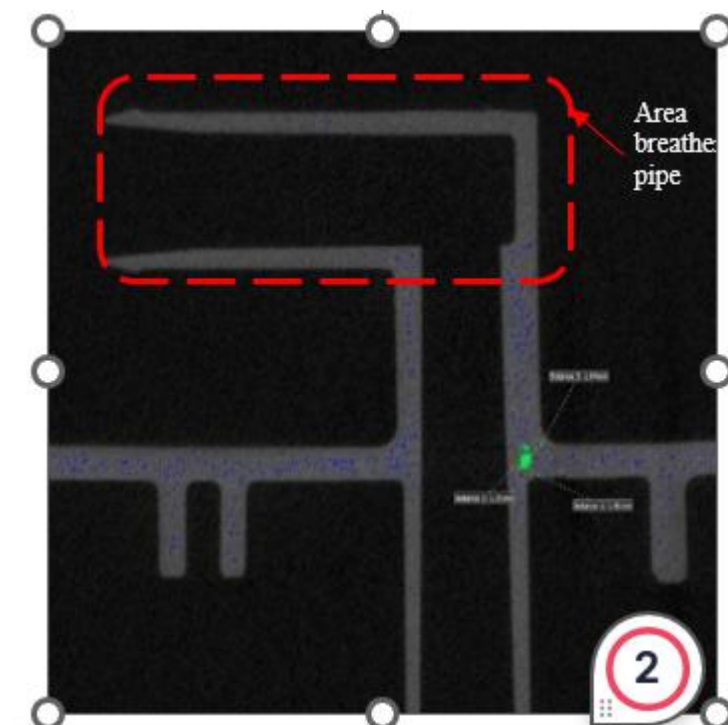
Figure 16
Void inspection by X-ray
There is no void in the breather pipe area

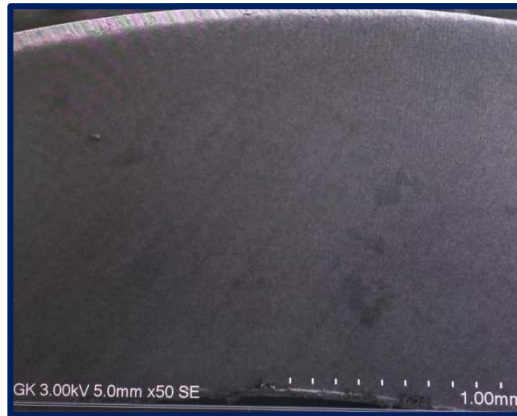
Figure 17

Integration inspection between layers of the inside of the breather pipe with SEM 50x magnification

In the SEM results, no voids were found, the integration between the layers was good and no delamination was obtained.

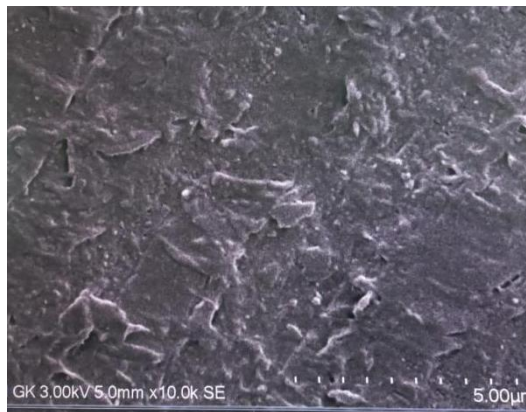
Figure 18

Inspection of the integration between layers of the inside of the breather pipe with SEM magnification 104x

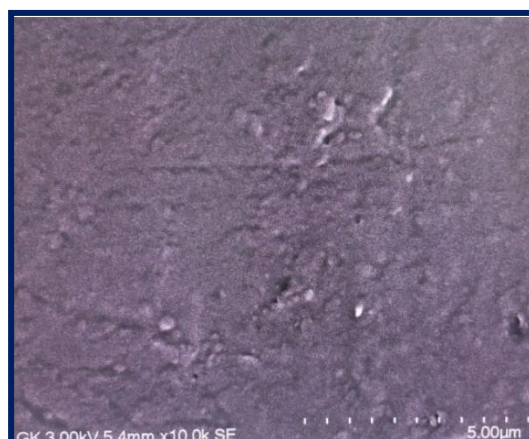
Figure 19

Inspection of the surface of the breather pipe in areas where delamination often occurred in the past with SEM magnification 104x.
