CFD Application to Eliminate Delamination Defects in Flange Products

Aep Supriatna

Institut Sains dan Teknologi Nasional (ISTN), Indonesia

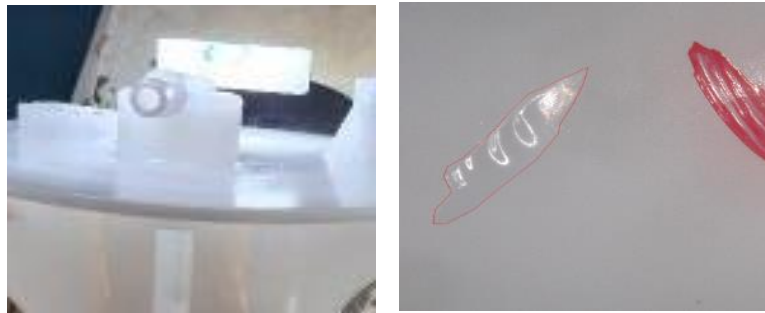
Figure 1
Delamination defects in breather pipe flange products

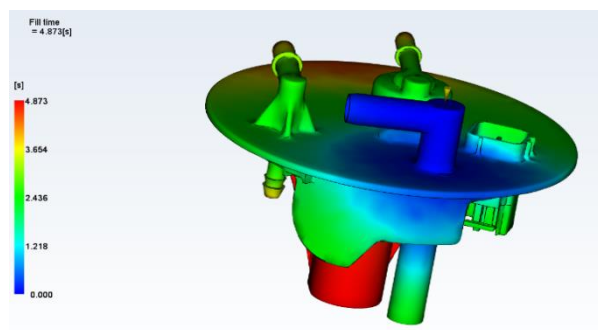
Figure 2
Fill time analysis

Filling the plastic resin into the mold, takes 4.87 seconds.

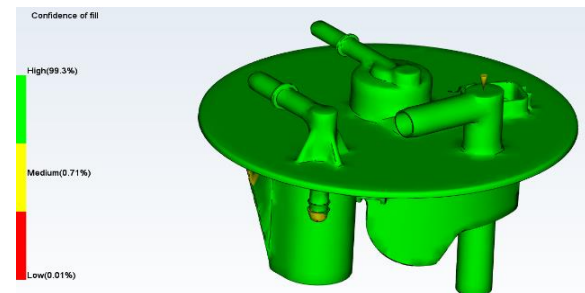
Gambar 3
Analysis Confident of fill

Based on the setting parameters used, the confidence of filling is 99.3%.

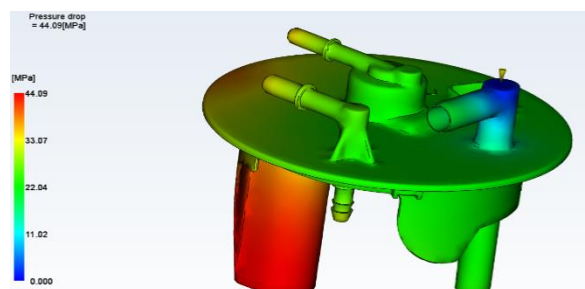
Figure 4
Pressure drop analysis

The pressure drop that occurred was 44.09 Mpa.

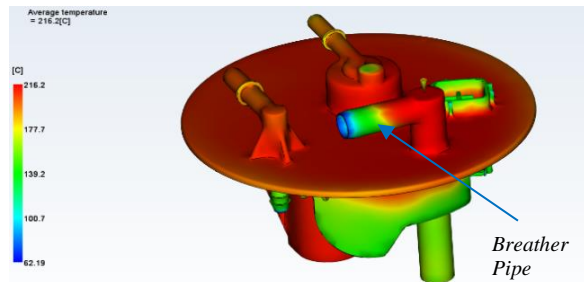
Figure 5
Temperature uniformity analysis

The average temperature is 216.2°C, but in the *breather pipe area*, there is a large enough temperature difference so there is the potential for delamination due to the lack of integrity between layers.

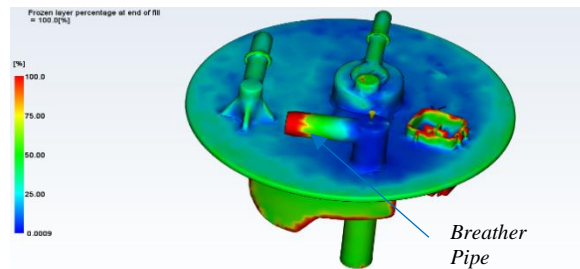
Figure 6
Frozen Layer Analysis

In the *breather pipe area*, there is a difference in the frozen layer on 1 surface.

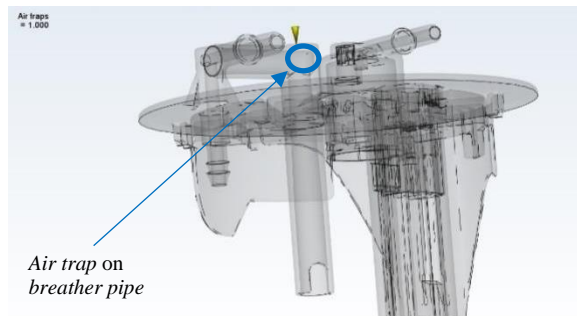
Figure 7
Analysis of Water Traps / trapped air

Air traps occur in the breather pipe area, this has the potential to cause voids due to gases that cannot get out of the mold.

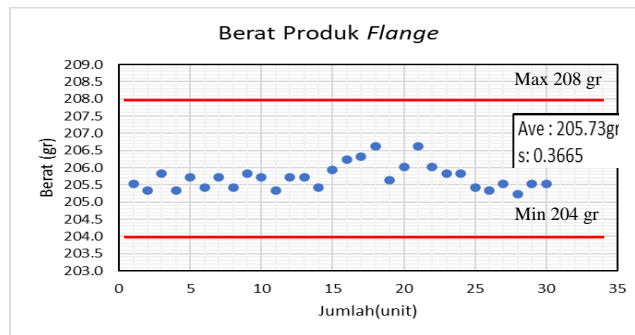
Figure 9 Weight Stability of Flange Products

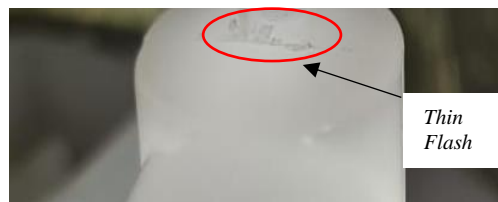
Plastic debris appear due to a thin *flash* in the parting line area near the *gate* that is easy to come off. The plastic debris that are sticky are also affected by the new resin material.

Figure 10
Thin Flash occurs on the parting line due to the failure of the slider core part

1. Eliminates thin flashes that easily fall off with the repair of the slider core to normal conditions.
2. Modification of cylinder rod to provide clearance of 0.5 mm.
3. The addition of gas vents in the slider area with a vacuum system to eliminate air traps as the cause of gas burn.

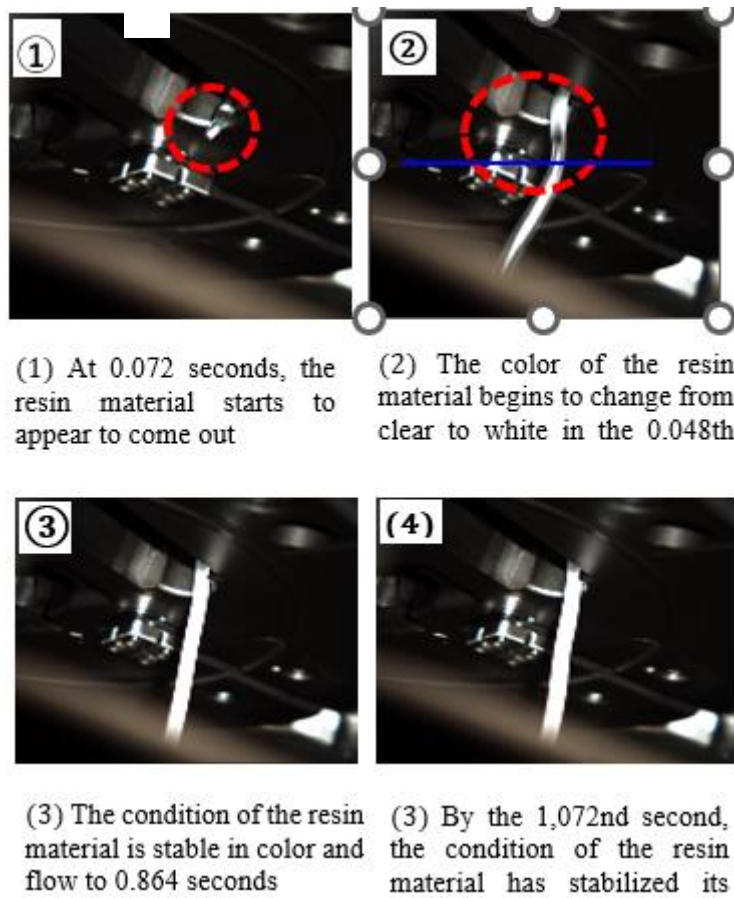
Figure 12
Results of checking foreign materials with high speed camera

From the results of checking the high camera, there was no foreign *material* , *bubbles* or delamination. Failure mechanism on *core scratch slider* and *gas burn problem*:

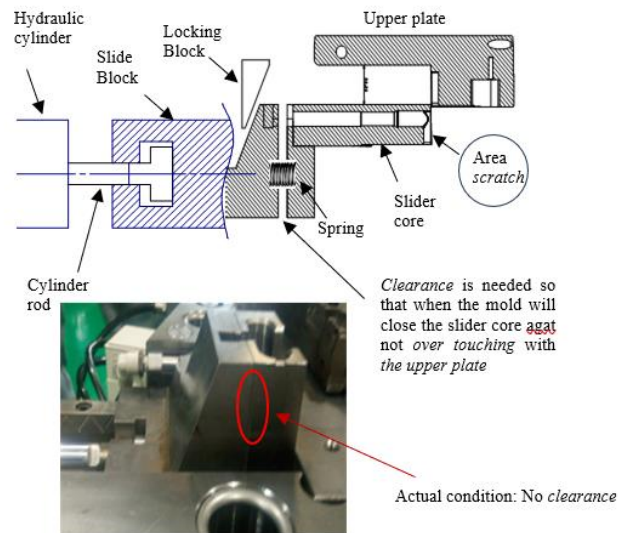
Figure 12 Mold Mechanism when closing

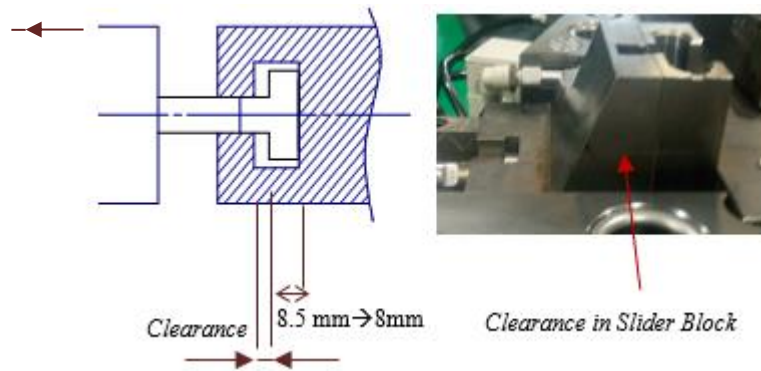
Figure 14
Cylinder Rod Modification

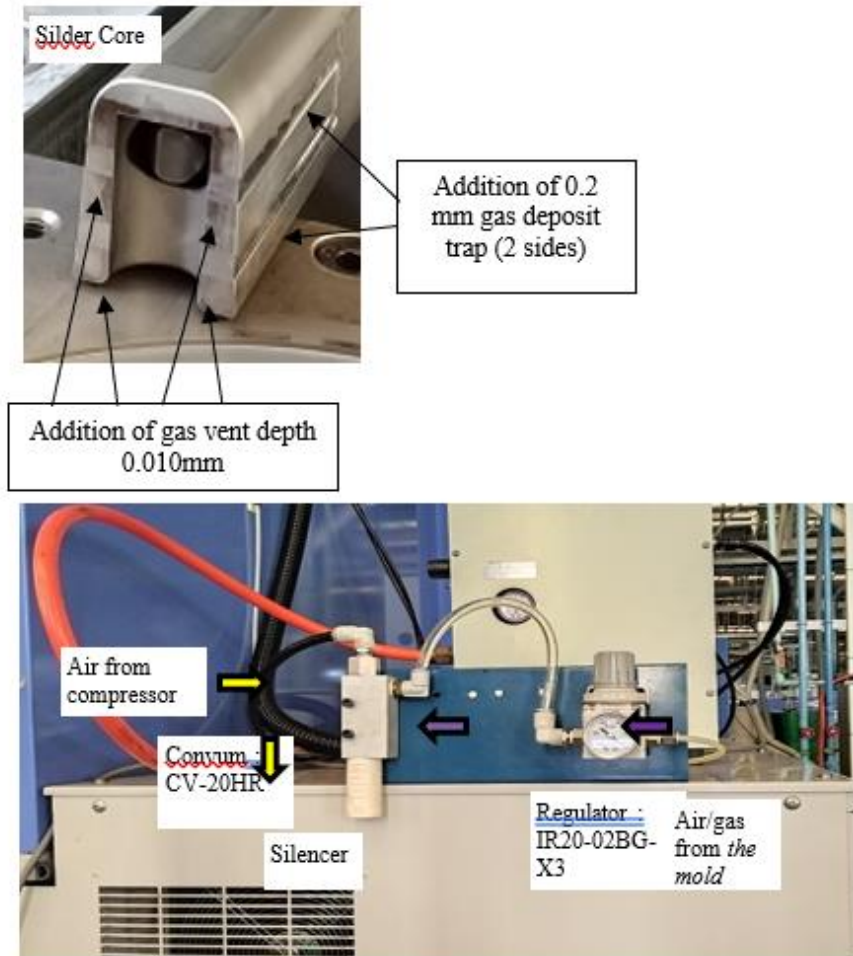
Figure 15
Addition of a gas vent to the slider core with a vacuum system

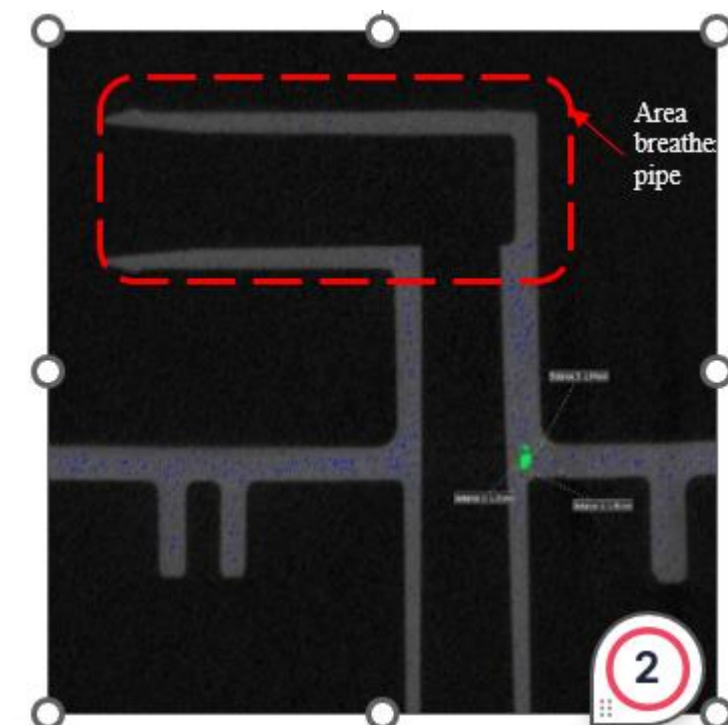
Figure 16
Void inspection by X-ray
There is no void in the breather pipe area

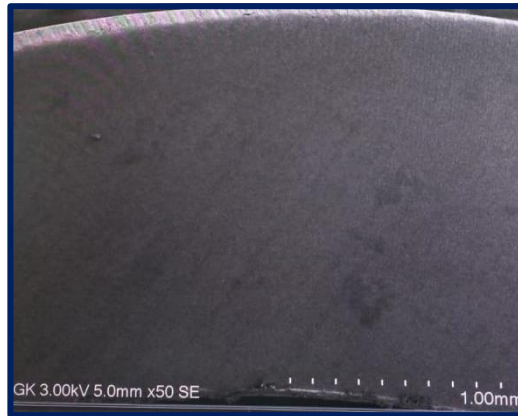
Figure 17

Integration inspection between layers of the inside of the breather pipe with SEM 50x magnification

In the SEM results, no voids were found, the integration between the layers was good and no delamination was obtained.

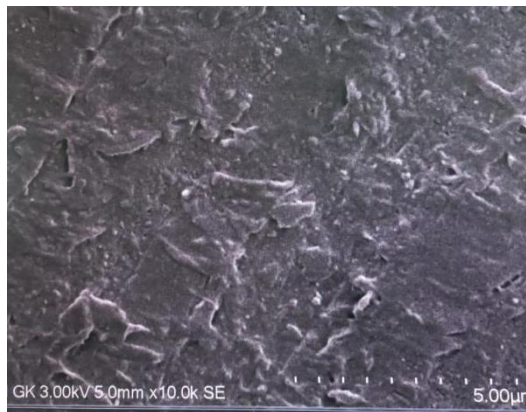
Figure 18

Inspection of the integration between layers of the inside of the breather pipe with SEM magnification 104x

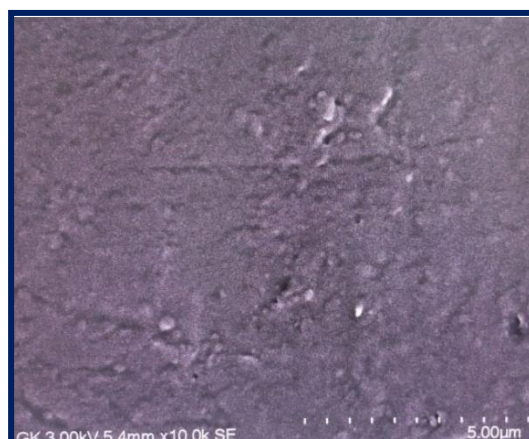
Figure 19

Inspection of the surface of the breather pipe in areas where delamination often occurred in the past with SEM magnification 104x.
