Maintenance Strategy for the Muliama-Wa2e-Makki Road Section in Jayawijaya Regency, Papua Province, Highlands

Elias Komba, Bahtiar, Harmonis Rante, Mujiati, Dewi Ana Rusim Universitas Cendrawasih Jayapura, Indonesia Email: <u>eliaskomba02@gmail.com</u>, <u>bahtiarpati2015@gmail.com</u>, harmonisrante72@yahoo.co.id, muji_js@yahoo.com, dewianarusim@yahoo.co.id

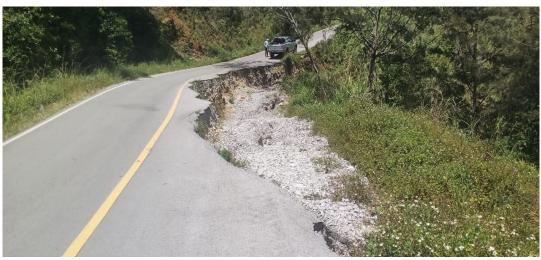
The damages occurring on the Muliama-Wame-Makki road section in 2021 (STA. 00 + 000 to 22 + 000) mostly consist of grade depressions, ruts, and a small portion of alligator cracks. The damages on the Muliama-Wame-Makki section can be seen in Figure 3.2, and the road depression damages can be observed in Figure 2 (Patil, Soni, Prakash, & Karwasra, 2022).

Figure 3. Road Damage: Grade Depressions (Survey 2021)
