## Seepage handling using a secant pile as a solution to replace curtain grouting and dam stability evaluation to optimize work on the Margatiga Dam construction project.

Ahmad Sidik

Institut Teknologi Sepuluh November Surabaya, Indonesia

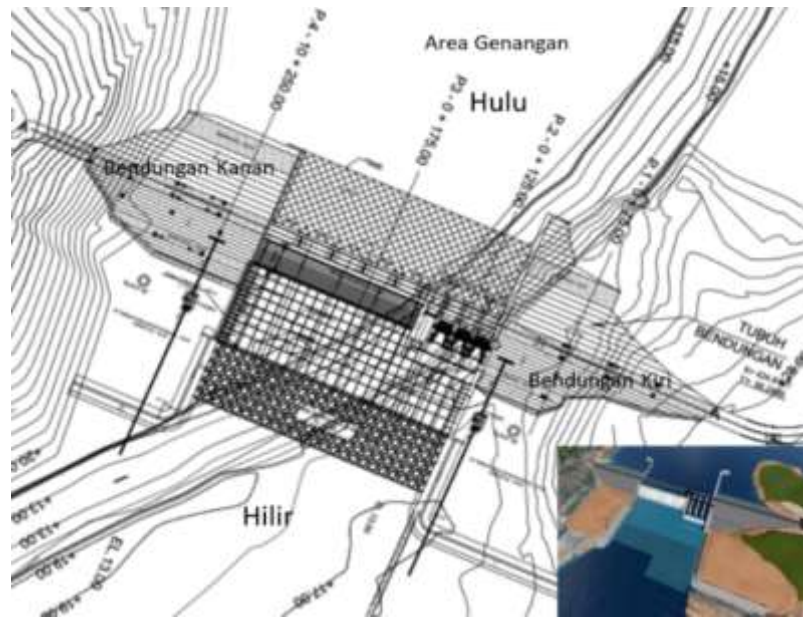
**Figure 3**  
**Layout and 3D Model of Margatiga Dam (Waskita - Adhi KSO Margatiga Dam Project, 2022)**

Margatiga Dam has a dam design type, namely a composite type dam with a combination of a gravity type concrete dam (concrete gravity dam) and a rock dam with an upright core (Sidik, 2024). Margatiga Dam will have a water storage capacity of 29.96 million m<sup>3</sup> for normal conditions or NWL (Normal Water Level) and 42.31 million m<sup>3</sup> for flood conditions or HWL (High Water Level). Margatiga Dam has a length of 321.76 m, with the right and left parts being the type of Arakan dam with an upright core, while in the middle of the dam is a type of concrete dam with spillway building types and retrieval buildings (Azizah, 2022). The spillway building is of the ogee spillway type, and in the retrieval building, there are 2 types of doors: radial doors totaling 3 units and funnel doors totaling 1 unit.

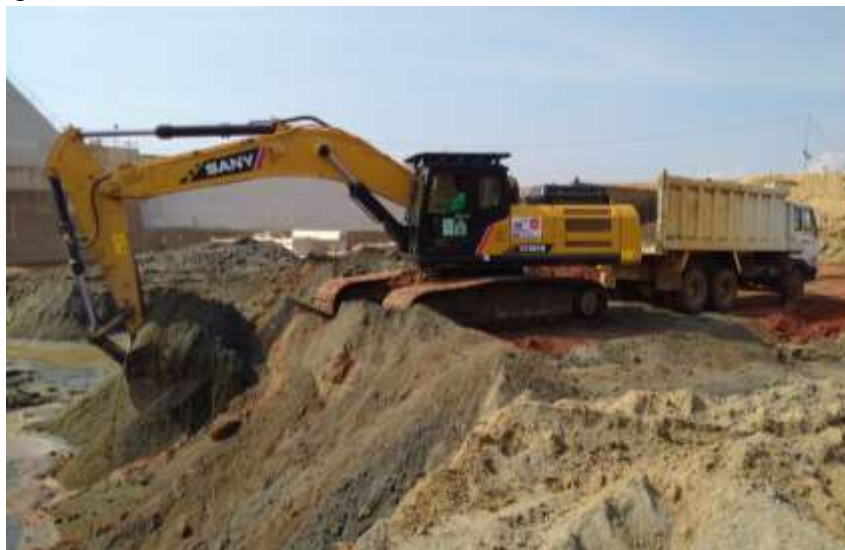
**Figure 5**

This lithology is found along the Way Sekampung river which dominates 35% of the Margatiga Dam area. Composed of loose material has not undergone compaction of silt to kerakal clay grains (Figure 4.2). This lithology is part of the Holocene Alluvium Unit.

**Lithology of alluvial deposits found in the main dam area of the Margatiga Dam (Margatiga Dam Work Observation, 2021)**

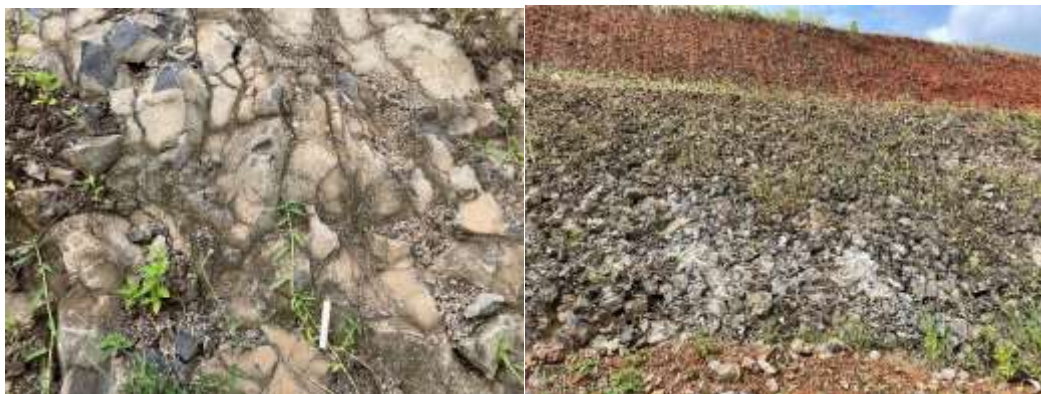
This lithology is found in the left abutment of the Margatiga Dam area (Fig.4.3). It dominates 20% of the employment area. Blackish-gray, very hard, vesicular / hollow structure due to the release of gases at the time of rock formation. It is part of the Pleistocene Sukadana Basalt Formation.

**Figure 6**  
**The condition of vesicular basalt lithological outcrops in the left main dam area of the Margatiga Dam (Margatiga Dam Work Observation, 2021)**

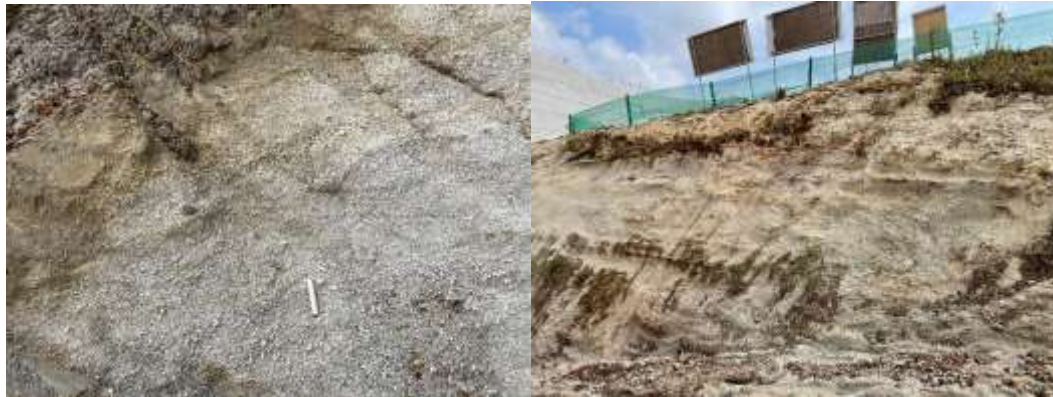
This lithology is found on the right and left abutments of the Margatiga Dam area. Dominating 45% of the work area is composed by interspersed fine and rough tuffs. Light – dark grey (Figure 4.4). It is thought to be part of the Plio-Pleistocene Lampung Formation.

**Figure 7**  
**Unit outcrop conditions per interlude of fine tuff and coarse tuff (Observation of Margatiga Dam Work, 2021)**

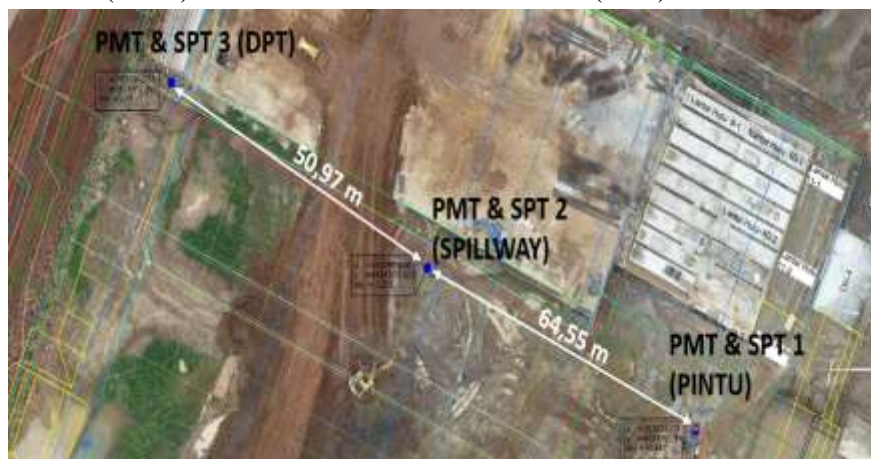
Subsurface investigations are carried out to obtain data and information on the types of constituent rocks and rock conditions including the level of weathering, rock structure, and rock hardness. This investigation was carried out with 2 types of methods, namely Pressure Meter Test (PMT) and Standard Penetration Test (SPT).

**Figure 8**  
**PMT & SPT test point layout (Geological Investigation Data, 2021)**

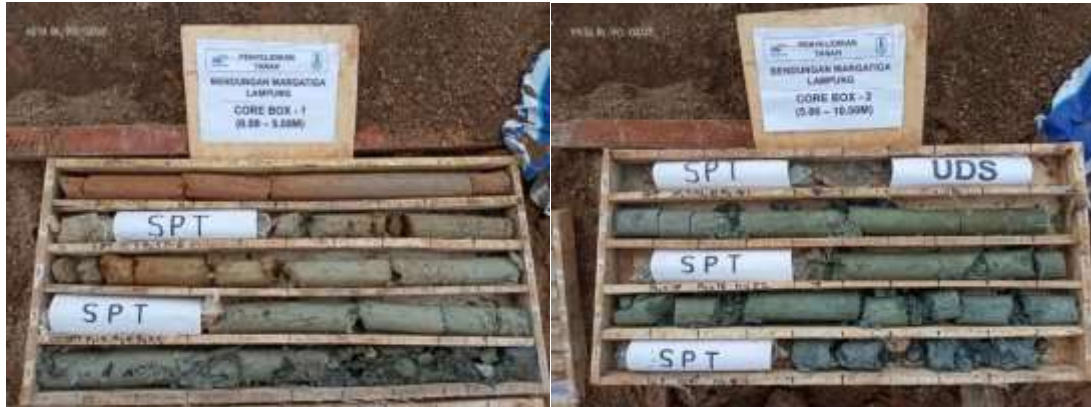
**Figure 10**

**Core box testing point PMT & SPT 1g (Geological Investigation Data, 2021)**

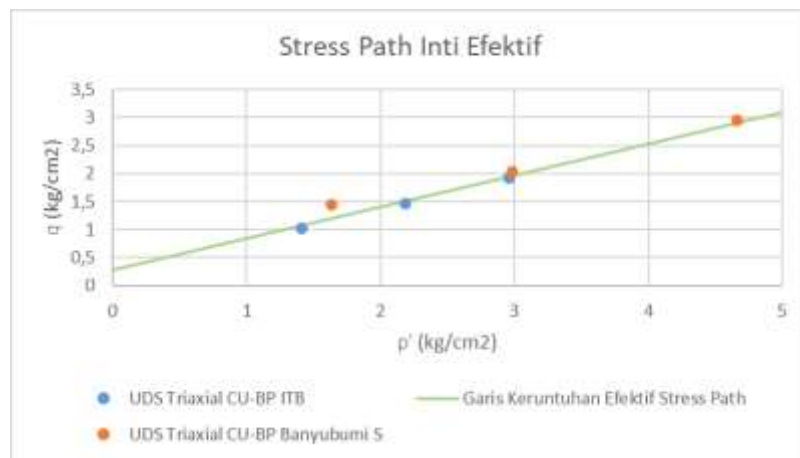
Laboratory and field tests conducted on core zone materials consist of testing soil shear strength, permeability, dry density, moisture content, and *property index*.

**Figure 11 Triaxial Core Shear Strength (Effective) CU-BP  $c' = 0.33 \text{ kg/cm}^2$  and  $f' = 34.33\%$  (Model Analysis, 2023)**

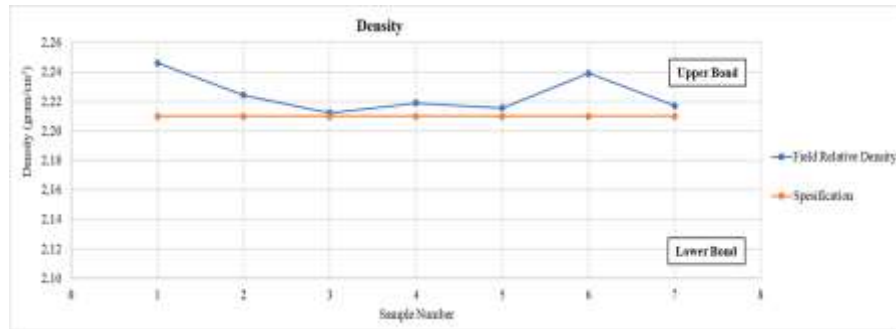
**Gambar 12 Density Rockfill**

Laboratory and field tests performed on rockfill zone materials consist of density testing. For other parameters, correlation is used to get it.
