Implementation of Pre-Cleaner as An Effort to Preventive Engine Lacks Power Bulldozer D85ess-2 Support Area Rom PT Putra Perkasa Abadi Site Mip Lahat

Kantor Putra Perkasa Abadi, Indonesia

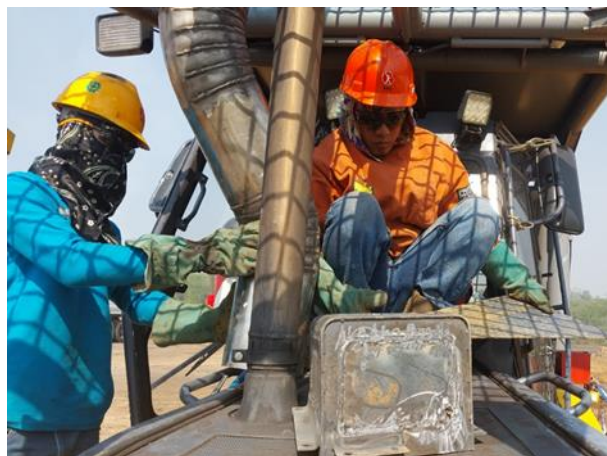
Figure 5 Pre-Cleaner Modification Process

After that, the installation of the pre-cleaner modification is carried out until the device is properly installed. At this stage, all components need to be installed precisely so that the pre-cleaner can function optimally. Once all the steps are completed and the pre-cleaner is installed, the device is ready to perform its function in filtering large particles from the air or fuel before entering the engine.

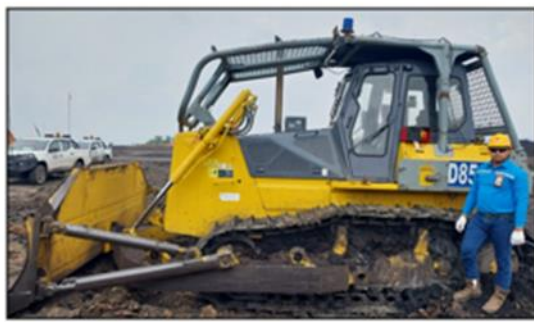
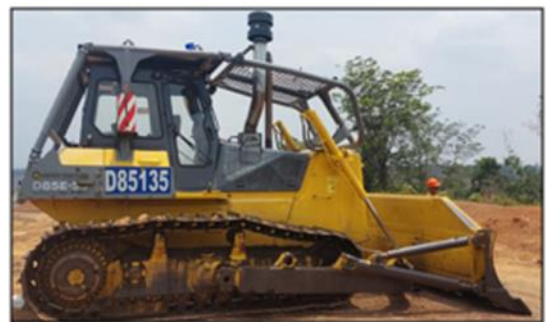
Figure 7 Difference after Pre-cleaner Modification on Air System

In figure (a), the state of the air system is shown before the pre-cleaner is installed. In this condition, the system may be more susceptible to the ingress of large particles, which can cause contamination and potentially damage engine components. In contrast, figure (b) shows the condition of the air system after the pre-cleaner is installed.
