## Implementation of Pre-Cleaner as An Effort to Preventive Engine Lacks Power Bulldozer D85ess-2 Support Area Rom PT Putra Perkasa Abadi Site Mip Lahat

Bulldozer D85ESS-2 operating in the ROM Support Area of PT Putra Perkasa Abadi Site MIP Lahat often experiences engine power problems, which disrupts productivity and increases maintenance costs. This problem is generally caused by air contamination entering the engine system, resulting in decreased combustion efficiency and component damage. This study aims to analyze the effectiveness of pre-cleaner implementation as a preventive measure in overcoming this problem. The method used was a quantitative approach with the collection and analysis of operational data from the D85ESS-2 bulldozer before and after the installation of the pre-cleaner. The data analyzed included the frequency of occurrence of the engine lack of power problem, downtime duration, and fuel usage. The results showed that the implementation of a pre-cleaner on the D85ESS-2 bulldozer at PT Putra Perkasa Abadi successfully resolved the problem of engine lacks power by reducing the accumulation of coal dust in the air cleaner. The test results show significant impr

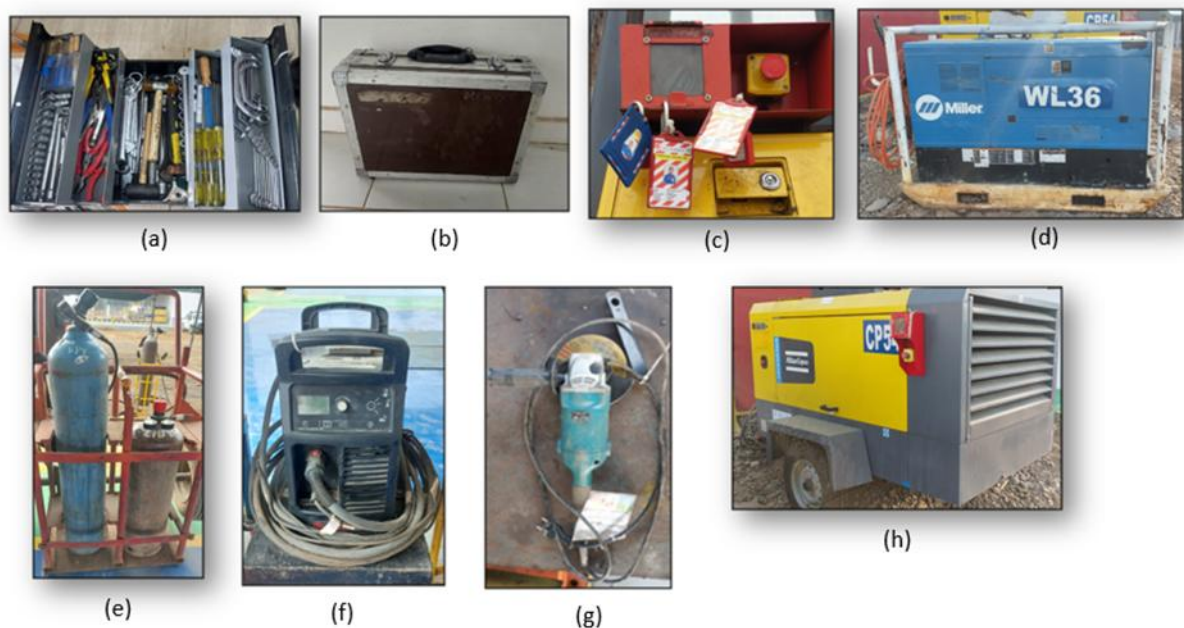
**Figure 3 Pre-cleaner Implementation Tools**

In figure (a), there are common tools that include basic tools commonly used in the repair process. Figure (b) shows the PPM tool kit, which contains specific tools for machine maintenance and repair. Figure (c) shows LOTO (Lockout-Tagout), which is a safety procedure to ensure that the machine cannot be started while repairs are being carried out. Furthermore, figure (d) depicts the welding machine, which is used for welding components during installation. Figure (e) shows oxygen and acetylene cylinders, which are required for the cutting and welding process. Figure (f) shows plasma cutting, a tool used to cut metal with high precision. Figure (g) shows a grinder, which is used to smooth or shape metal surfaces. Finally, figure (h) shows a compressor, which is used to provide compressed air in a variety of applications, including dusting or operating pneumatic tools.

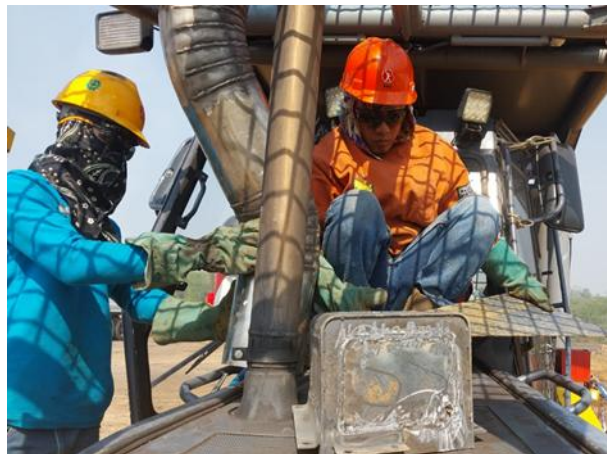
**Figure 5 Pre-Cleaner Modification Process**

After that, the installation of the pre-cleaner modification is carried out until the device is properly installed. At this stage, all components need to be installed precisely so that the pre-cleaner can function optimally. Once all the steps are completed and the pre-cleaner is installed, the device is ready to perform its function in filtering large particles from the air or fuel before entering the engine.

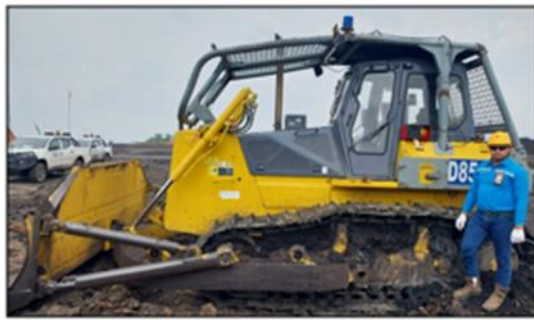
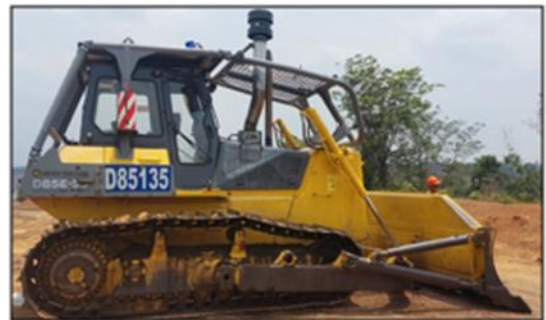
**Figure 7 Difference after Pre-cleaner Modification on Air System**

In figure (a), the state of the air system is shown before the pre-cleaner is installed. In this condition, the system may be more susceptible to the ingress of large particles, which can cause contamination and potentially damage engine components. In contrast, figure (b) shows the condition of the air system after the pre-cleaner is installed.

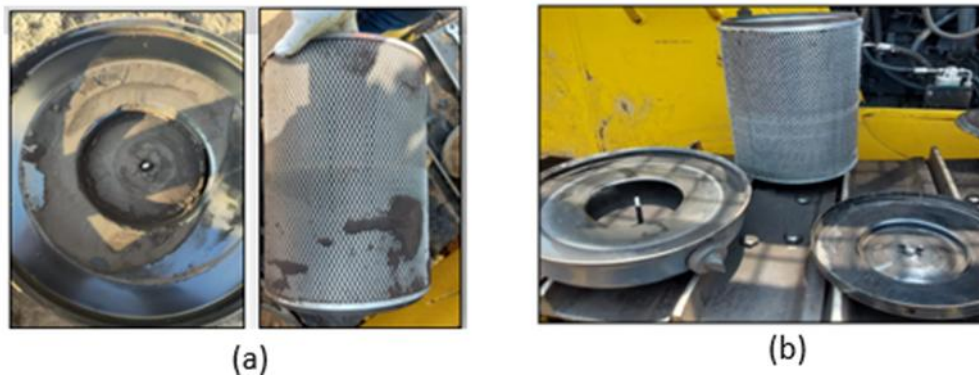
**Figure 8 Comparison After Modification**

The figure shows a comparison of the system conditions after pre-cleaner modification, with two sub-figures: (a) before modification and (b) after modification. From the figure, it can be seen that the amount of coal dust entering the air cleaner is significantly reduced after the improvement. This shows that the pre-cleaner modification was successful in filtering and reducing dust contamination that could previously enter the system.
