CFD Application to Eliminate Delamination Defects in Flange Products

Aep Supriatna

Institut Sains dan Teknologi Nasional (ISTN), Indonesia

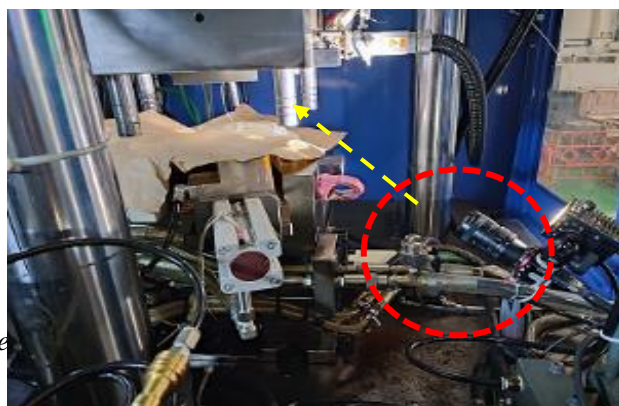
Figure 11
Checking foreign materials with a high speed camera

Ensuring the source of plastic debris from the cylinder injection process and hot runner is carried out by checking the high speed camera through the mold purging method.

Setting parameter used :
Screw metering (SM) = 105 mm
Velocity (V) = 10 mm/s

High Speed camera position

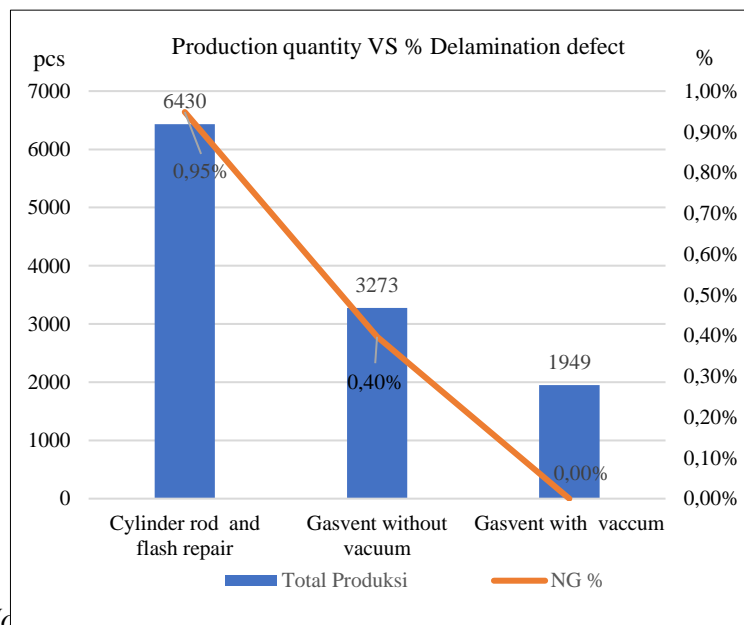
Figure 16
Graph 2 Production Data after 3 stages of improvement

A 100% visual inspection is carried out to check the delamination throughout the production process. X-ray and microscopic /SEM testing is also carried out to ensure that there are no significant voids in the breather pipe and that the integrity between the layers of the material is maintained.

1. Eliminates thin flashes that easily fall off with the repair of the slider core to normal conditions.
2. Modification of cylinder rod to provide clearance of 0.5 mm.
3. The addition of gas vents in the slider area with a vacuum system to eliminate air traps as the cause of gas burn.
