Maintenance Strategy for the Muliama-Wa2e-Makki Road Section in Jayawijaya Regency, Papua Province, Highlands

Elias Komba, Bahtiar, Harmonis Rante, Mujiati, Dewi Ana Rusim Universitas Cendrawasih Jayapura, Indonesia Email: <u>eliaskomba02@gmail.com</u>, <u>bahtiarpati2015@gmail.com</u>, harmonisrante72@yahoo.co.id, muji_js@yahoo.com, dewianarusim@yahoo.co.id

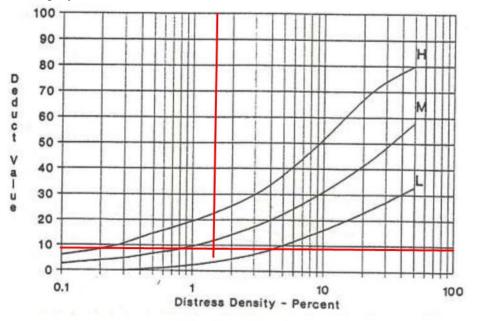
Figure 6 Deduct Value Curve for Patching Type

Patching located at STA 1+200 to STA 1+400 measured a patching area of 1.8m wide and 7m long. The damage falls into the category L (Low) because the patching is still new. Thus, the density is calculated as $(1.8 \times 7)/(4 \times 200) \times 100\% = 1.58\%$.

category line, a horizontal line is drawn towards the DV and the DV nominal value intersecting the horizontal line is read. Thus, for a density of 1.58% with category L, a DV of 4 is obtained.

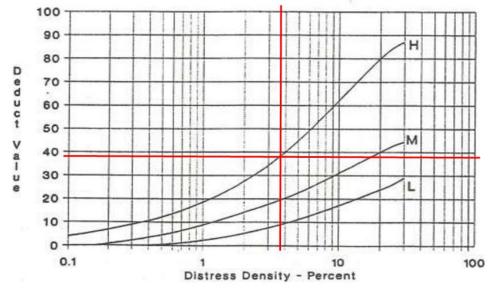
Figure 7 Deduct Value Curve for Longitudinal Crack Type

Longitudinal cracks located at STA 1+600 to STA 1+800 measured a longitudinal crack area of 0.7m wide and 9.8m long. The damage falls into the category M (Medium) because its width exceeds 7.6 cm and is surrounded by light random cracks. Thus, the density is calculated as $(0.7 \times 9.8)/(4 \times 200) \times 100\% = 0.86\%$.

Longitudinal cracks located at STA 1+600 to STA 1+800 with a density of 0.86% obtain a DV of 8.

To find the DV value on the graph, a straight line is drawn towards the damage category curve based on the density result. Then, after hitting the category line, a horizontal line is drawn towards the DV, and the DV nominal value intersecting the horizontal line is read. Thus, for a density of 0.86% with category M, a DV of 8 is obtained.

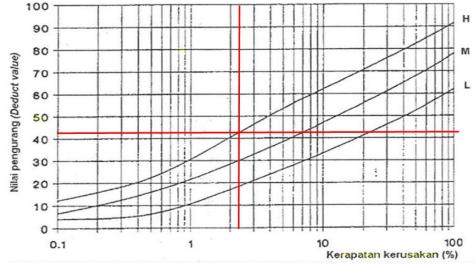
Figure 8 Deduct Value Curve for Alligator Crack Type

Alligator cracking located at STA 2+600 to STA 2+800 measured an alligator crack area of 2m wide and 9.3m long. The damage falls into the category H (High) because the crack width exceeds 3 mm and there has been particle release. Thus, the density is calculated as $(2 \times 9.3)/(4 \times 200) \times 100\%$ = 2.33%.

Alligator cracking located at STA 2+600 to STA 2+800 with a density of 2.33% obtain a DV of 42.

To find the DV value on the graph, a straight line is drawn towards the damage category curve based on the density result. Then, after hitting the category line, a horizontal line is drawn towards the DV, and the DV nominal value intersecting the horizontal line is read. Thus, for a density of 2.33% with category H, a DV of 42 is obtained.

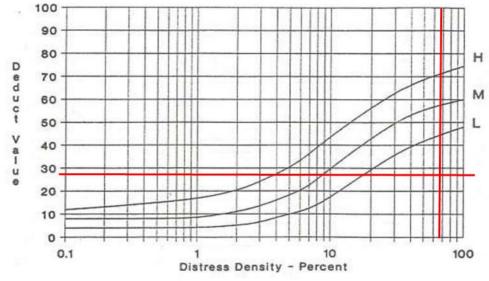
Figure 9 Deduct Value Curve for Depressions

Depressions located at STA 6+000 to STA 6+200 measured a depression area of 1.8m wide and 17.3m long. The damage falls into the category H (High) because the depth of the damage exceeds 5 cm. Thus, the density is calculated as $(1.8 \times 17.3)/(4 \times 200) \times 100\% = 3.89\%$.

Depressions located at STA 6+000 to STA 6+200 with a density of 3.89% obtain a DV of 28.

To find the DV value on the graph, a straight line is drawn towards the damage category curve based on the density result. Then, after hitting the category line, a horizontal line is drawn towards the DV, and the DV nominal value intersecting the horizontal line is read. Thus, for a density of 3.89% with category H, a DV of 28 is obtained.
