Exhaust Temperature Control of Double Tail Flue Boiler

PT. DSSP Power Kendari, Indonesia

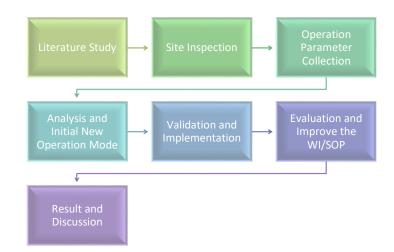
The study involved a detailed analysis of a double-tail flue boiler with adjustable burners. Temperature sensors were strategically placed throughout the boiler to monitor exhaust temperatures, and actuators were used to adjust burner angles. Experimental methods were employed to evaluate the effectiveness of control strategies.
